# Field monitoring challenges. Episode 1

## Unforeseen piling details and damage to inclinometer casing

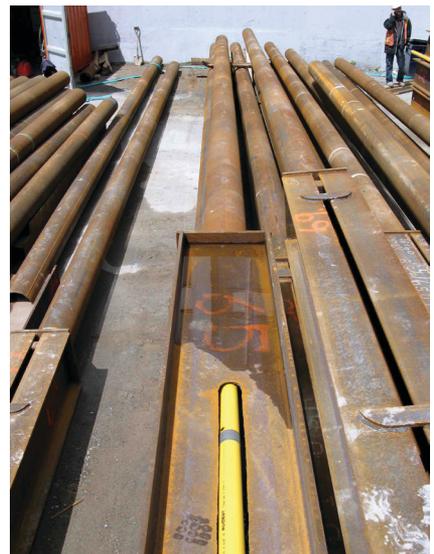
Figure 1. Lower section of pile with inclinometer casing transition to pipe pile.

An installation method was devised to run the casing along the outside of the double pile at the upper end. A long notch was cut out of the middle of the pile nearing the transition to the pipe pile at the bottom. The inclinometer would be slightly curved to run down into the notch and into the centre of the pipe pile below, shown in Figure 1.

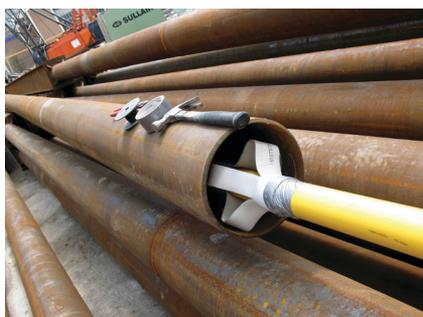
Figure 2. Centralizers in pipe pile section.

To avoid excessive movement in the pipe pile section that would affect readings, centralizers were positioned along the length of the casing as seen

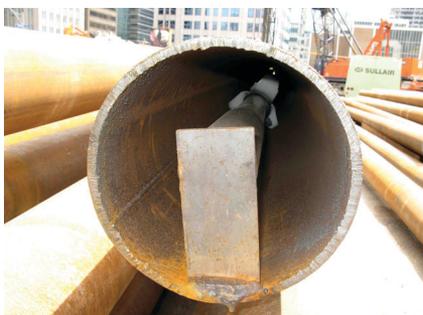
Figure 3. Custom welded inclinometer base.

in Figure 2. Figure 3 shows a custom-made base, consisting of a metal tube (which would contain the bottom of the inclinometer casing) welded to a flat plate, which was in turn welded to the edge of the bottom of the pipe pile to prevent any downward movement of the inclinometer casing.
